COMPTON HILL RESERVOIR

ST. LOUIS, MISSOURI

MO 31696

PHASE 1 INSPECTION REPORT NATIONAL DAM SAFETY PROGRAM

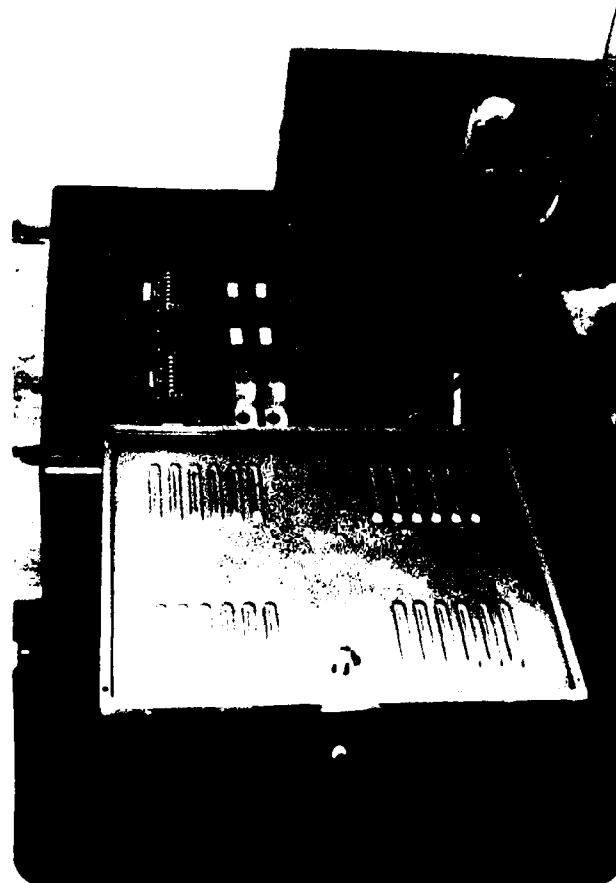
telemetering control panel (see Photo 18) within the west gate house appeared to be relatively new and well maintained. The staff gage, manual gate operators (see Photo 17) as well as the standby generator (see Photo 19) within the west gate house and the manual operators at the east gate chamber (see Photo 15) were examined and also found to be well maintained and in satisfactory condition.

| <u>NO.</u> | <u>DESCRIPTION</u> |
|---|--|
| 18 | Telemeter Controller at West Gate House |
